Our ref: 6397/JHM

19th May 2017

**RE: Suffolk House, Boundary Retaining Wall assessment along Romilly Road, Canton, Cardiff**

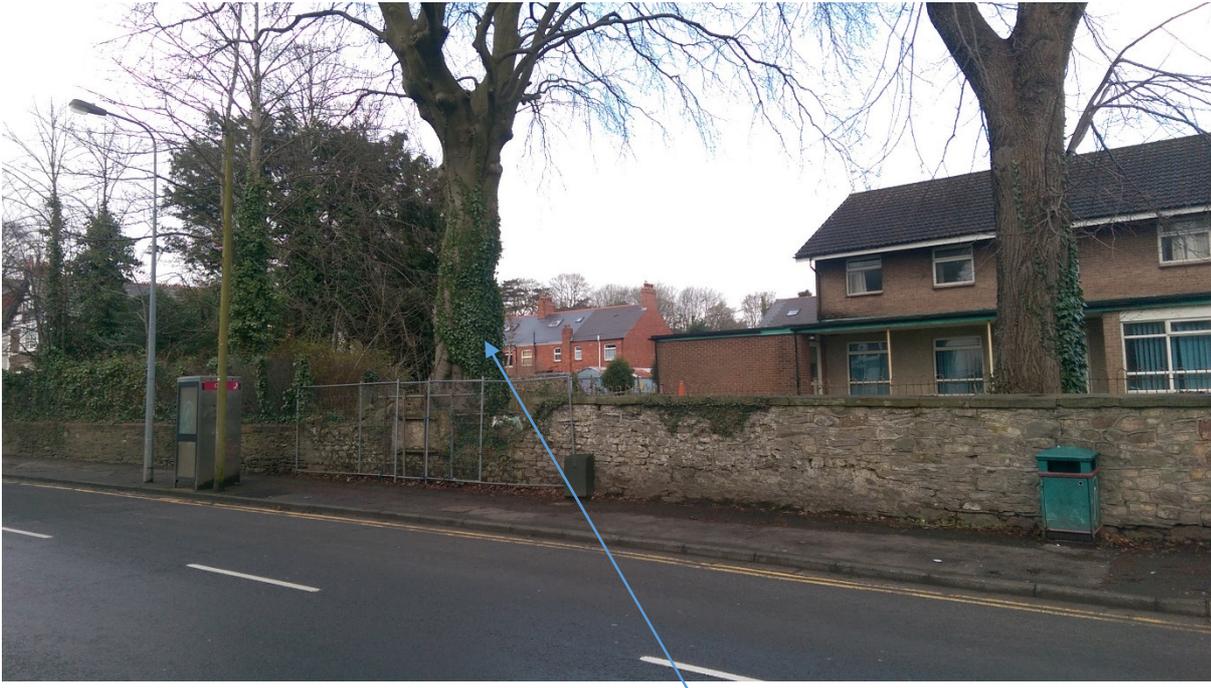
It can be seen from a visual inspection that the retaining walls are bowing and leaning over by as much as 125mm at the top of the wall (greatest opposite the common lime tree, T5). Localised cracking in the mortar joints, in the wall is also evident around the location of the trees. (See photographs 1 & 2)

It is our professional opinion that the section of wall adjacent the larger Copper beech tree and Common Lime T5 & T6 is close to complete failure and therefore, poses a serious risk to the safety of public using the pavement, especially near the bus stop. The partial failure of the wall around the Copper Beech tree T6, clearly shows that the tree root growth is causing the failure.

Photo 1, Extent of wall requiring re building, T6 (Left) adjacent partial collapse wall.

The retaining wall will need to be completely re-built over its entire length effected by the trees, using a concrete reinforced wall finished in stone cladding to match existing appearance. A section of the proposed retaining wall construction is attached to this report (Ref, SK03), which has been calculated to current design standards.

We recommend that the wall is re-built with some urgency as there is a risk that complete failure of the wall could occur at any time. It is also of our opinion that an appropriately designed retaining wall constructed in the wall's current position cannot be carried out without significantly undermining the root bases of the existing Copper Beech and Common Lime trees, which are currently being retained by the wall. Due to the pavement and highway adjacent the wall, it would be necessary to fell the trees, prior to further demolition/removal of the existing wall, prior to rebuilding a suitable retaining wall (see 6397 SK02), detailed method statements and risk assessment should be submitted to meet CDM & H&S requirements.

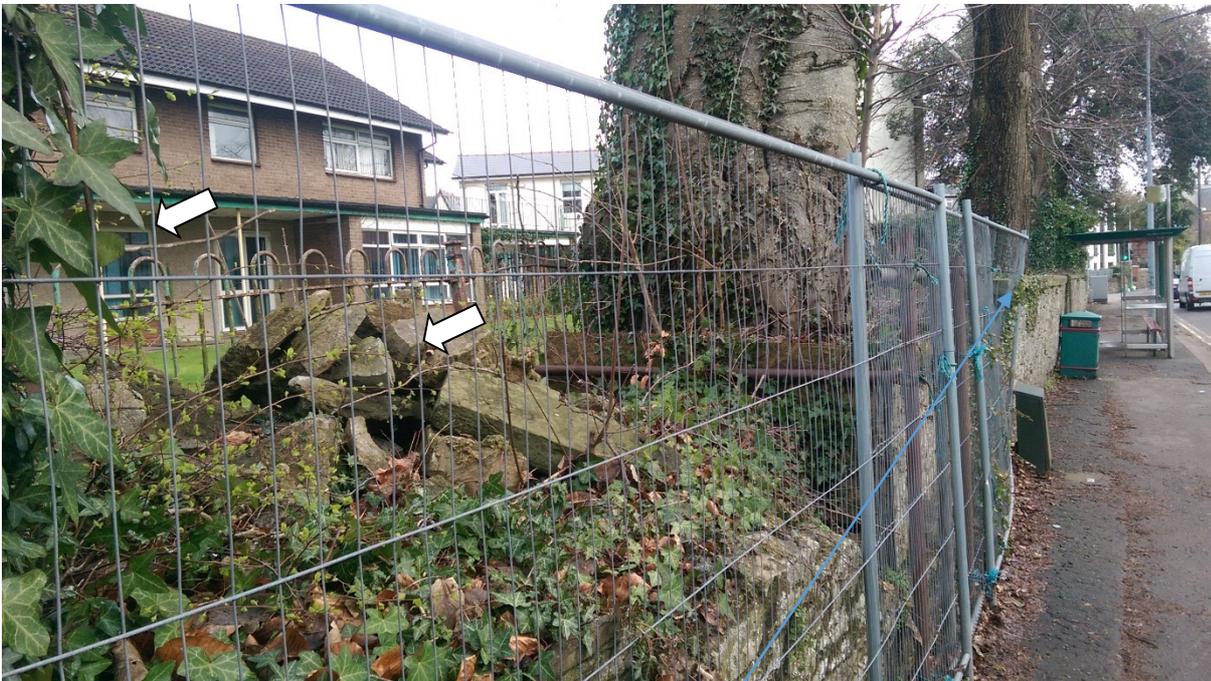
T5 & T6 are causing the most significant damage to the walls, T6 being the tree which has caused the wall to failure & T5 causing the wall to bow and lean out towards the pavement to an extent that the wall is touching the waste litter bin.

Photo 2, Lean in wall visible over entire length. T5 tree behind waste litter bin.
